# GUIDELINES FOR RETIREMENT OF TWIN-PATH® SLINGS

## EXAMPLES OF NON-REPAIRABLE DAMAGE

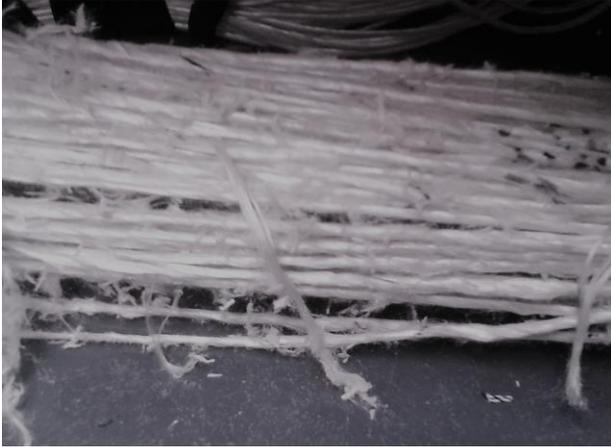
## YARN-ON-YARN ABRASION

Severe degradation from yarn-on-yarn abrasion. The coating on the fibers shows wear and tear and individual fibers have broken. Besides abrasion, exposure to heat can also contribute to this effect.

Often found in repetitive lifting applications, such as general manufacturing environments like automotive stamping plants.

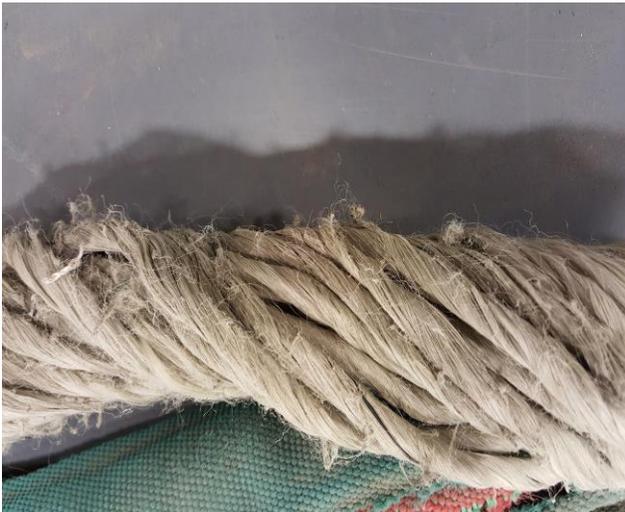
## YARN-ON-YARN ABRASION (CONTINUED)

Extreme abrasion between the core yarns, to the point where the fibers have started to separate. This example contains an aramid fiber which is more susceptible to yarn-on-yarn abrasion vs. HMPE.

Often found where the sling is subjected to repeated movement over a surface, such as vibratory hammer applications.

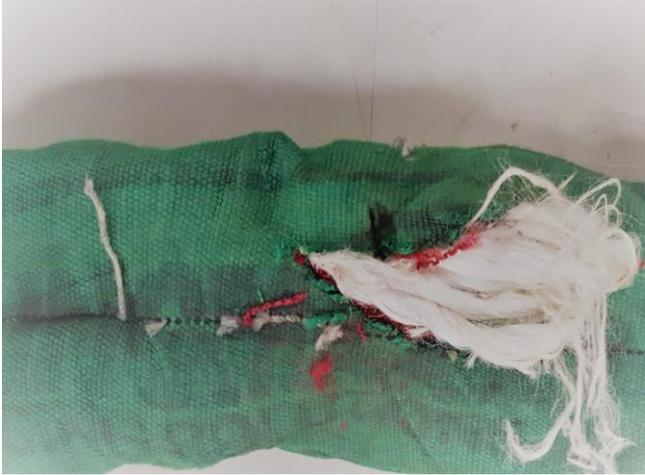
## SNAGGING

The cover of the roundsling was torn and pulled open, exposing the core yarns and pulling them out of the cover. Most likely caused by the sling sliding over a rough or gouged bearing point.

Often found where roundslings contact unprotected steel edges, such as construction or demolition sites or gouged crane hooks.

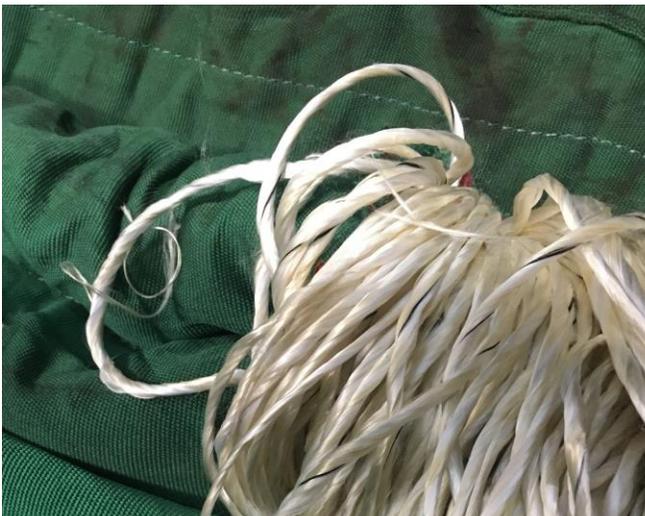
## SNAGGING (CONTINUED)

The roundsling was snagged on a sharp object that penetrated the cover. The core yarns were pulled out of the cover for inspection, whereby several fibers in multiple strands were found to be cut.

Often found where slings have been pulled from under an object or placed on a contact surface such as a hook or trunnion with nicks and gouges.

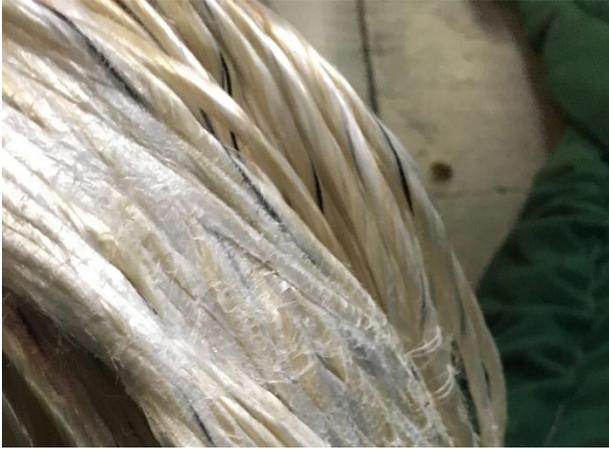
## HEAT OR FRICTION

The core yarns have fused together because of heat buildup. This is most likely at a location where the bearing point of the sling was never changed or rotated or a small D/d ratio.

Often found in automotive stamping and vibratory hammer applications.

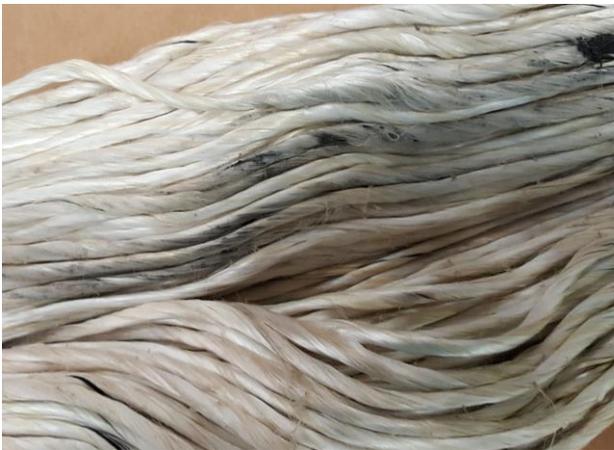
## HEAT OR FRICTION (CONTINUED)

Note the discoloration of the core yarns. Several of the core yarns have also started to fuse together at the contact point of the heat source.

Often found in areas with a high ambient temperature, such as steel mills or on blacktop pavement on hot, sunny days.

Also found in slings that are stored in high temperature containers.

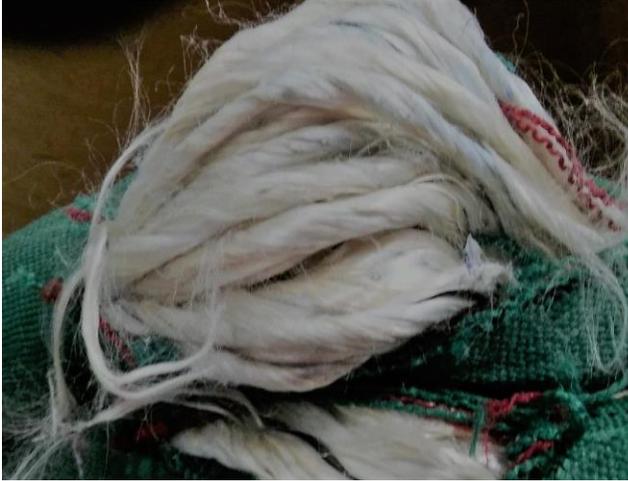
## CUTTING

The roundsling jacket and multiple core fibers were cut due to lack of protection around a contact surface.

Often found in harsh environments such as construction sites or mining applications where the roundsling contacts unprotected load edges.

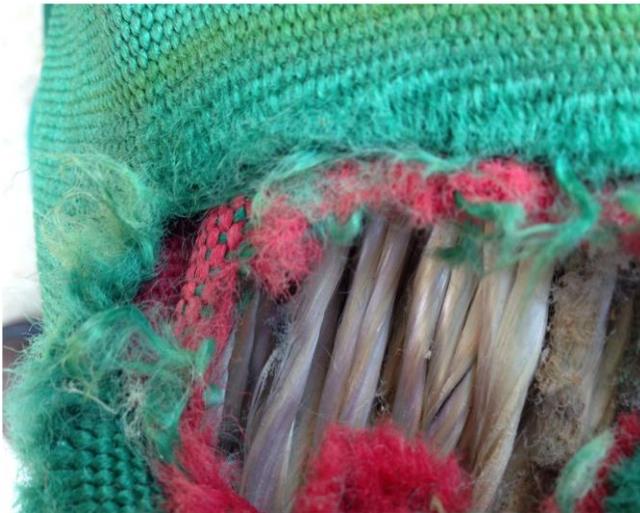
## CUTTING (CONTINUED)

Partially abraded/cut core yarn (left) and heat/abrasion damage (right) from contact with a 'sharp' edge. The roundsling was pulled around an edge without proper protection.

Often found in applications such as steel coil lifting, steel milling environments and construction H-beams being lifted without proper sling protection.
