# Hidden damage in slings corrosion and ultraviolet light

*Strength loss associated with metal corrosion of wire rope and ultraviolet light degradation of synthetic fibers.*

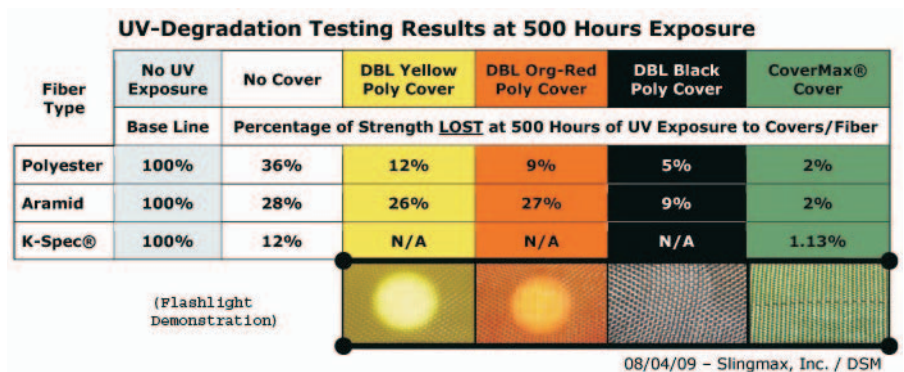
(N/A indicates that K-Spec® load bearing core fiber is never used inside these types of covers)

The following chart displays test results of UV degradation to varying roundsling cores and covers used by riggers around the world. This testing was requested by Slingmax® Rigging Solutions and conducted independently by Murdock Webbing Company in the United States and DSM in The Netherlands. Murdock Webbing performed UV testing and residual strength testing was done by DSM Dyneema®. Despite being much more expensive than our initial “flashlight testing,” it shows the same basic results. The field test of any cover may be quite simple. If you hold a flashlight against the cover and do not see light shining through the other side, it’s a good sign.

A study of the above chart shows the vast difference in the protection afforded by various types of roundsling covers. The dark green Covermax® is much thicker than other roundsling covers and therefore, the loss of the sling’s core strength is negligible. Roundslings protected by the thinner lighter colored covers lost the most core strength.

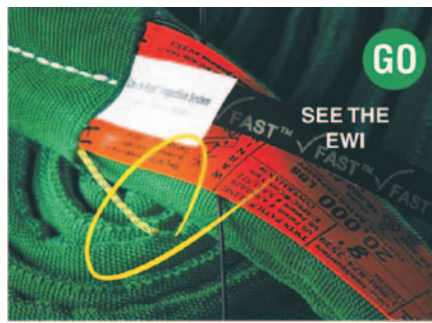
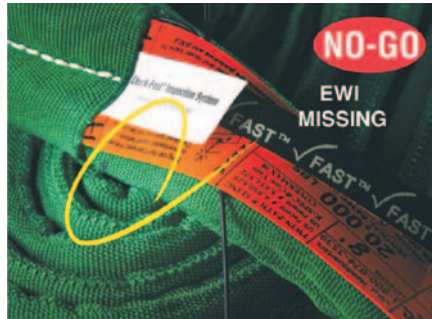
**Fast® Inspection System, US Patent #7,661,737. Foreign Patents Pending**

The next question is this: Is there a mechanical way to determine “hidden” UV damage in a roundsling? The answer is yes! On February 16, 2010 the United States issued a patent to Slingmax® Rigging Solutions (US #7,661,737) for a pre-failure warning indication system for all roundslings. It’s called the Check-Fast® inspection system. The following is a brief explanation of how it works.

sling made with the Check-Fast® inspection system adds an extra wrap called a “sacrificial strand.” The ends of this independent strand are equally tensioned among the other load bearing core yarns via a “weak link.” The weak link material has a calculated lower breaking strength than the core yarn material. Also, it degrades faster when exposed to ultraviolet light. Therefore, when the sling is exposed to severe overload or in this case, severe UV damage, the weak link breaks first, well before the remaining strands reach their failure point. Finally, a colored External Warning Indicator (EWI) strand is attached to the weak link and will disappear inside the sling cover when the weak link fails. This is what the rigger looks for upon each inspection. If you see this indicator yarn and there is no other cover damage, it is a GO! If the roundsling is subjected to severe overload when tensioned, or in this case, severe UV deterioration, the weak link breaks and whips the indicator strand inside the cover so fast it makes an audible POP sound.

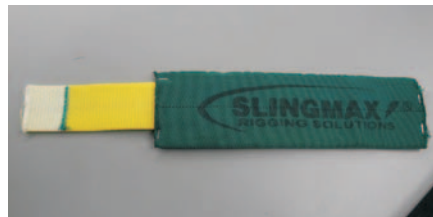
Pictured above is yellow 9800GN nylon web sling material protected by Slingmax® Covermax® roundsling tubing. The exposed webbing faded to white after 334 hours of UV exposure. When the nylon web was pulled out of the protective Slingmax® cover, you can see the original yellow color remains. It shows no UV degradation to the protected webbing.
