# Cut Protection

Slingmax® Dealer Conference 2019  
San Diego, CA

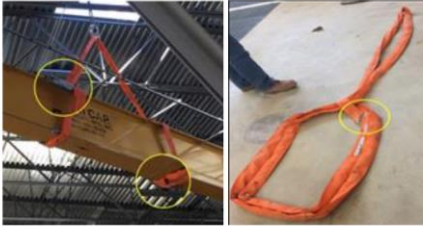
On July 15, 2017, at the Stanford Linear Accelerator Center, a bridge crane girder dropped 15 feet during a lift by a mobile crane. Slings slipped off softeners during the lift because dynamic forces applied during the lift increased the horizontal force on the slings, which overcame the force of friction on the softener. The slings failed when they contacted the edge of the load. (See photos below.) There were no injuries. The girder and the concrete floor were damaged when the load dropped. (ORPS Report SC--SSO-SU-SLAC-2017-0003)

Photos showing sling failure that caused girder to drop

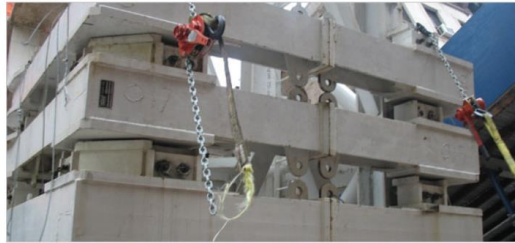
A ragged nylon strap was hanging from the topmost of the crane's three collars on Saturday.  
Robert Solarik for The New York Times

A prime suspect in Saturday's East Side crane collapse — a spectacular disaster across two Manhattan blocks that has now claimed seven lives and is expected to cost untold millions — is a \$50 piece of nylon webbing that investigators suspect may have broken while hoisting a six-ton piece of steel.

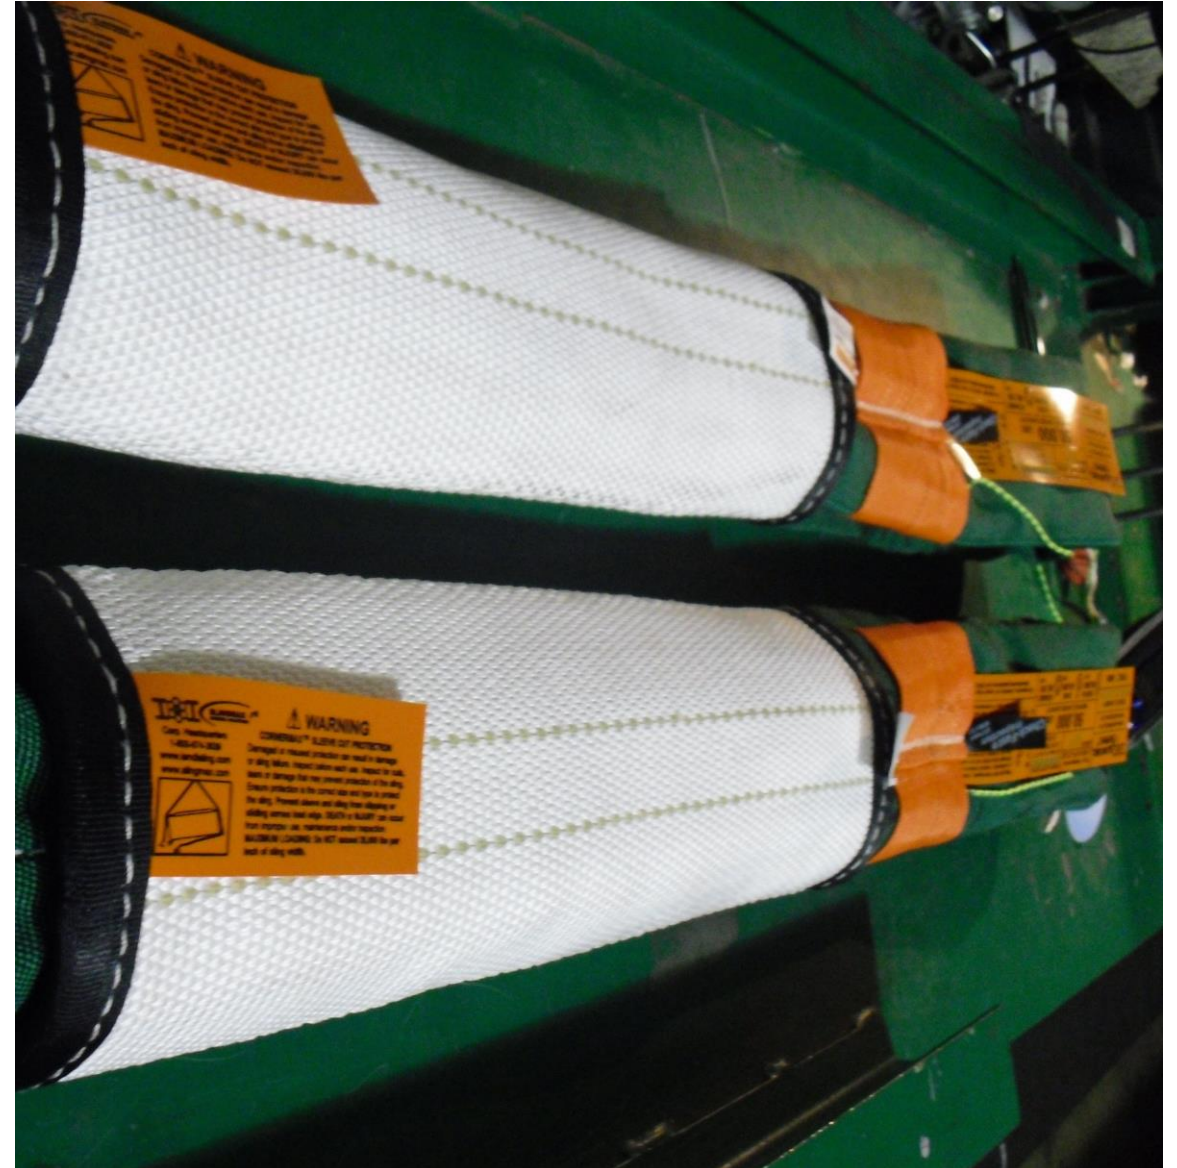
- From 2015 to 2018: Doubling of sales (growing market)
- Customers want/demand rated protection
- Can be used in endless applications (opportunities)
- Add-on appeal

# CornerMax Sleeve

- Engineered protection for irregular surfaces or limited space
- Rated: 25,000 lb. per inch of sling width
- Proprietary cut resistant sleeve construction

- Tested on steel blocks with sharp edges
- Maximizes synthetic sling performance
- No damage shown at and above rated load

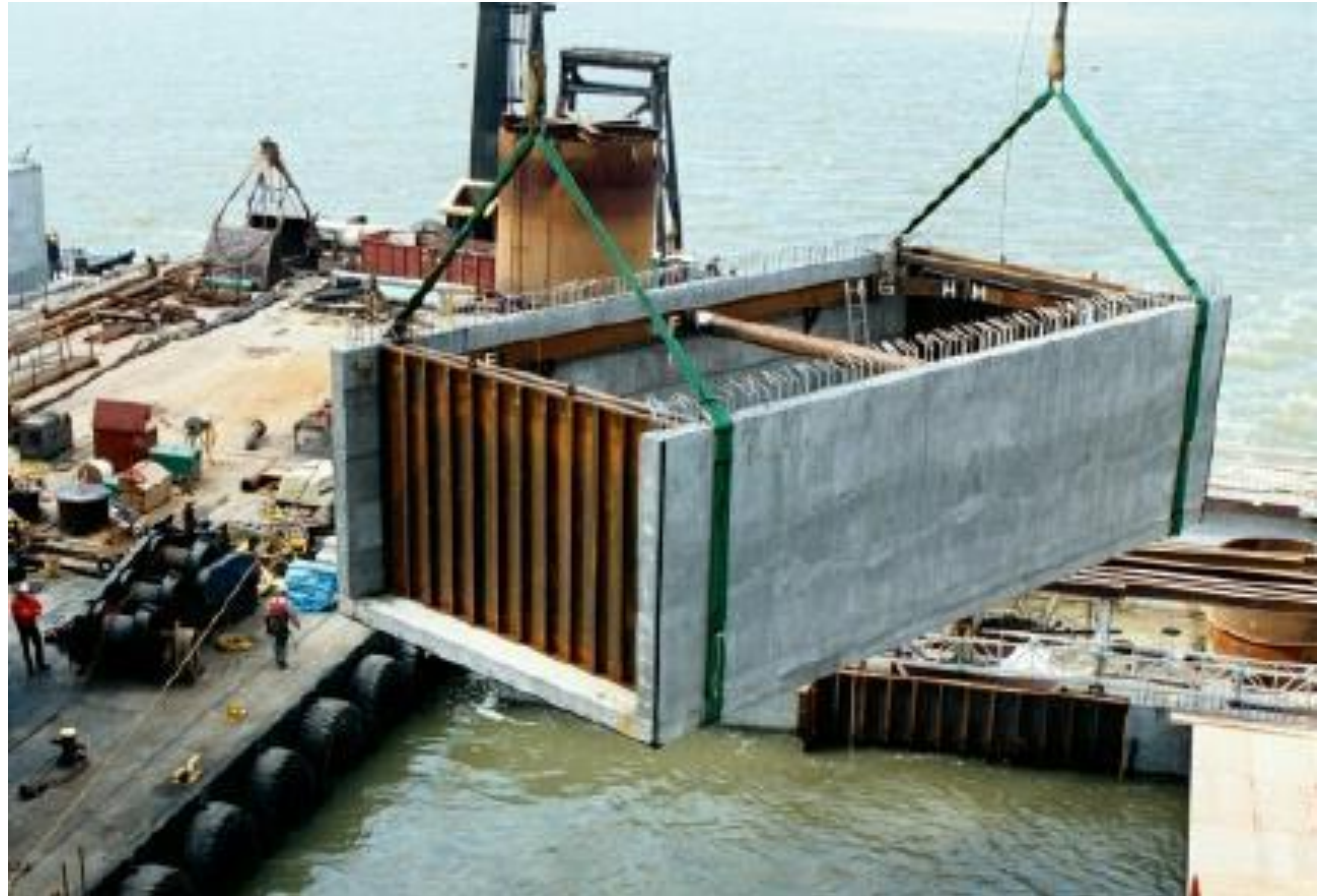
- Any surface or edge can be of concern during loading
- Synthetic slings should always be used with protection
  - Abrasive surfaces
  - Edges
  - Corners
  - Protrusions
  - Hardware

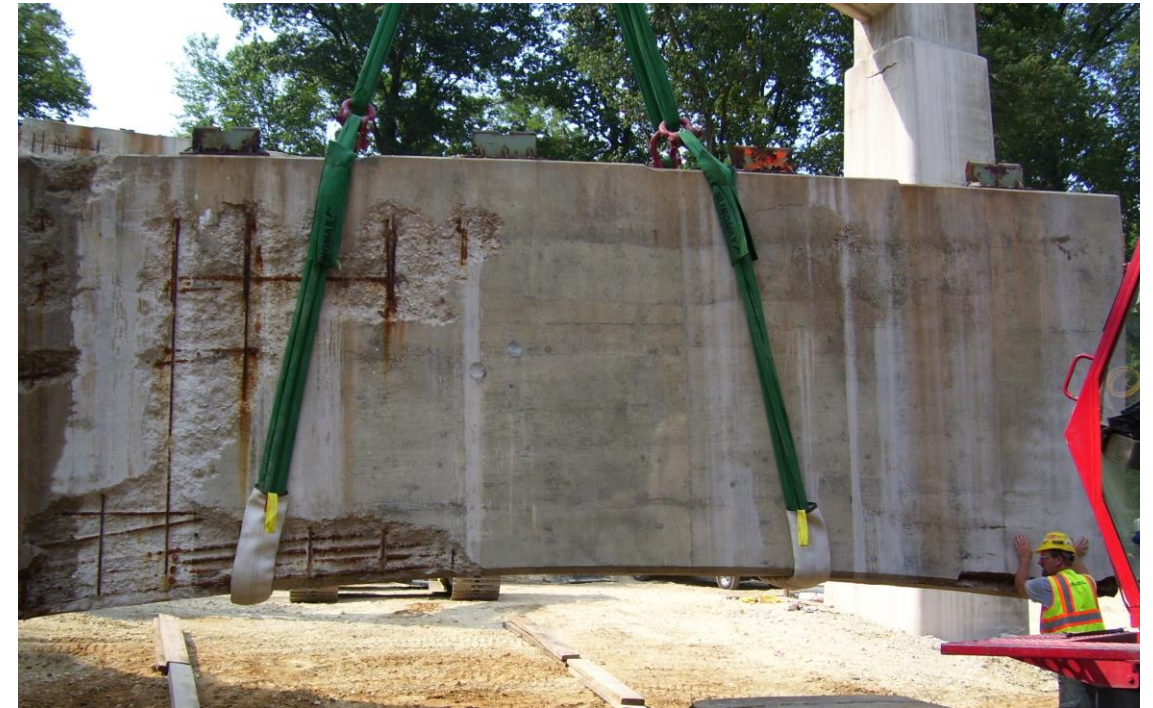
Damage from applied, concentrated pressure

Load features

- Corners
- Edges

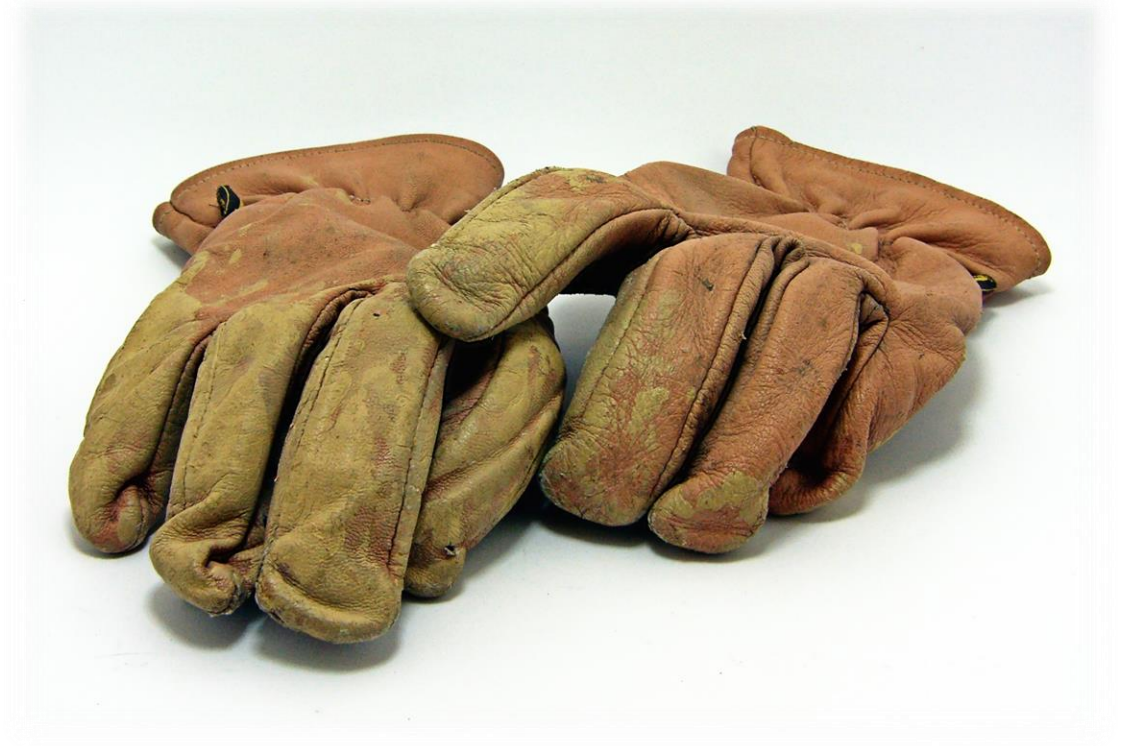
- Improvised cut protection
  - Gloves
  - Old Slings
  - Firehose
  - Rubber
- Proven to be ineffective
- Highly dependent on riggers in field to determine what to use
- Not designed for sling type
- Should be tested before use

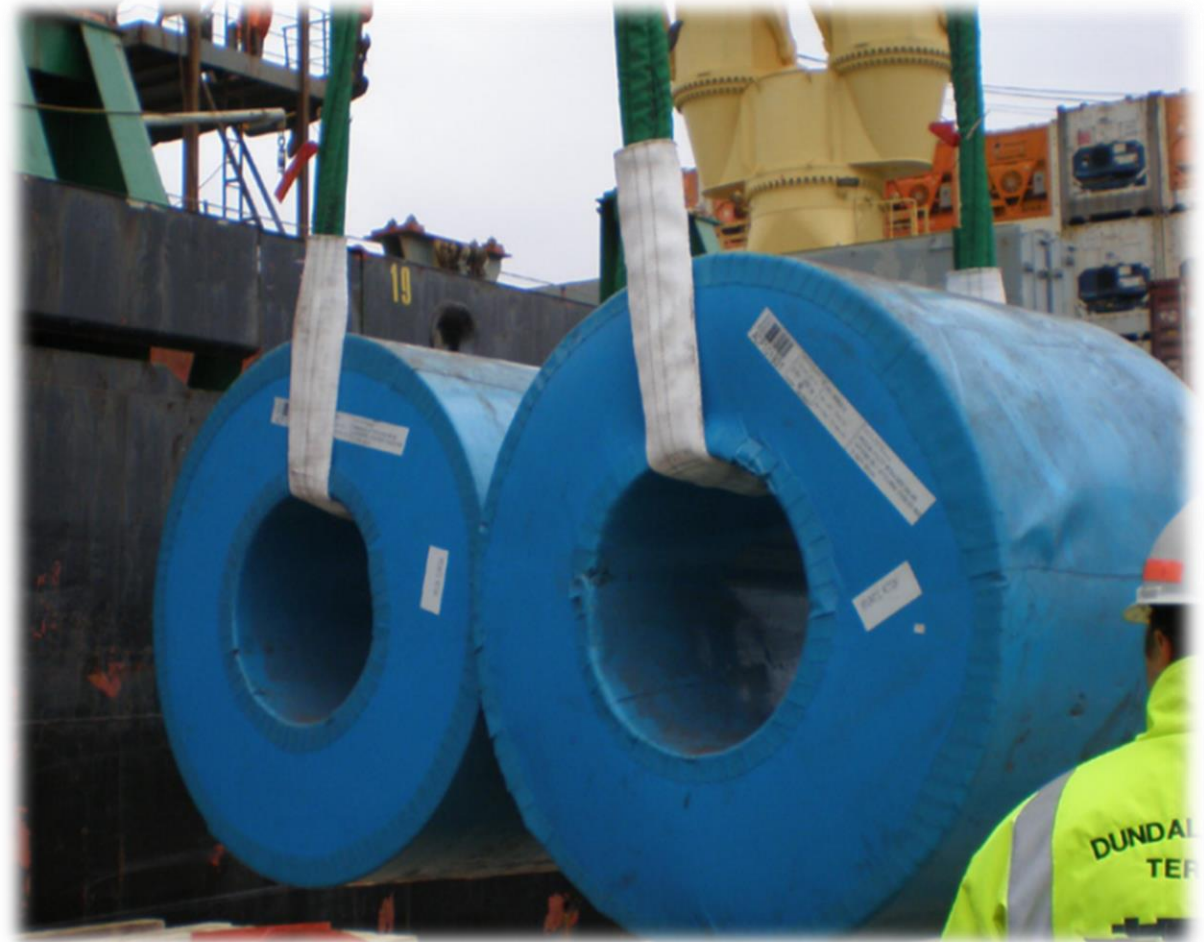
- Engineered cut protection
- Rated protection backed by testing
- Designed specifically for sling
- Simple– minimizes risk of misuse

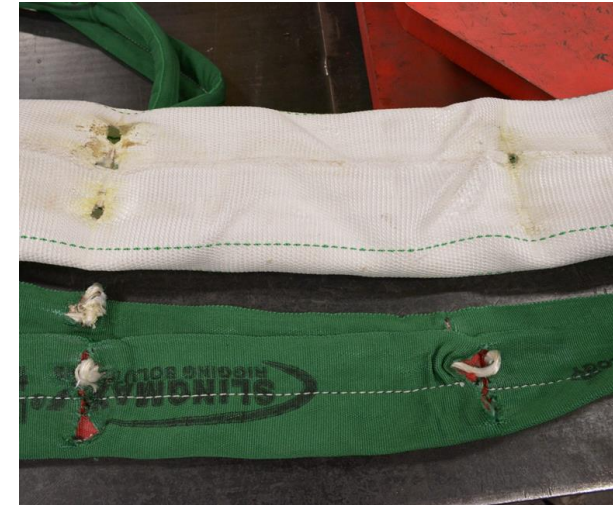
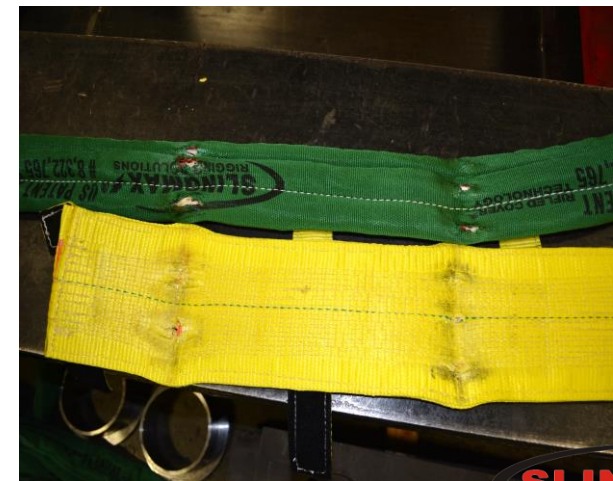
- More than 20% higher break strength over 90 deg edge

- Practical shortcomings (flexibility, etc.)
- Comparable protection to nylon web

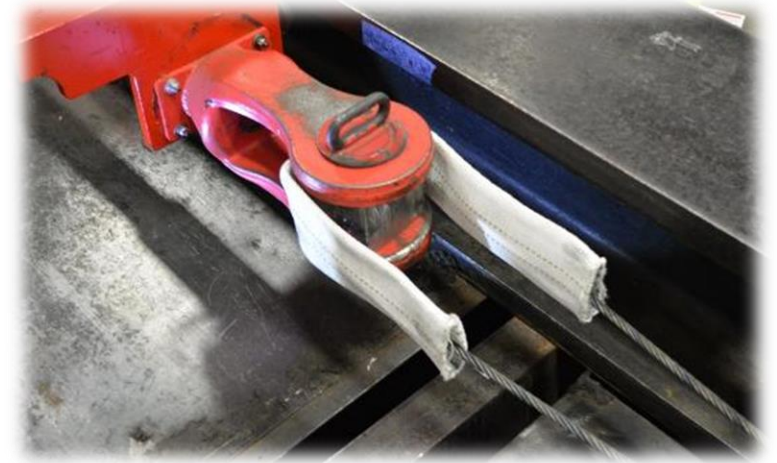
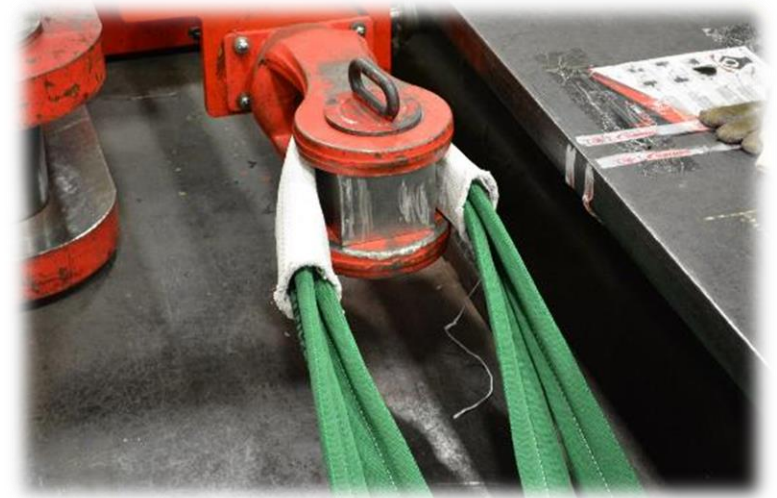
- Synthetic slings **with protection** outperform competition
- Cut protection helps sell synthetic slings

Sling	TPXC 1000	TPXC 1000 w/ CMS	SP900	½" FE	½" FE w/ CMS	½" FE Control
Hitch	Basket	Basket	Basket	Basket	Basket	Basket
WLL	20,000 lb	20,000 lb	18,000 lb	10,200 lb	10,200 lb	10,200 lb
MBF	100,000 lb	100,000 lb	90,000 lb	51,000 lb	51,000 lb	51,000 lb
BF	60,070 lb	92,800 lb	35,590 lb	32,513 lb	41,170 lb	49,620 lb
DF	<b>3.0:1</b>	<b>4.6:1</b>	<b>2.0:1</b>	<b>3.2:1</b>	<b>4.0:1</b>	<b>4.9:1</b>
