Hidden damage in slings corrosion and ultraviolet light

by Dennis St. Germain

Strength loss associated with metal corrosion of wire rope and ultraviolet light degradation of synthetic fibers.

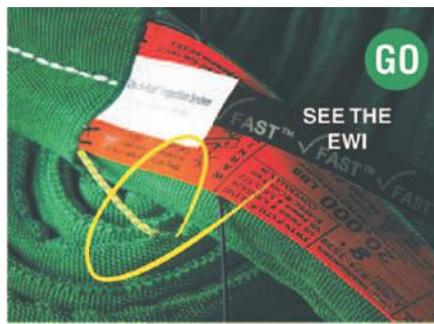
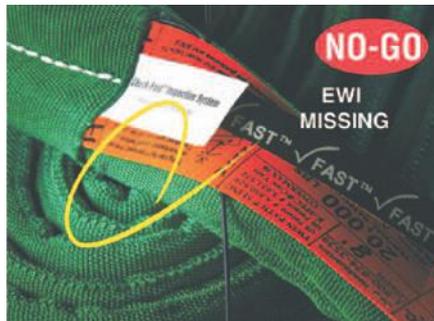
Fast® Inspection System, US Patent #7,661,737. Foreign Patents Pending

The next question is this: Is there a mechanical way to determine “hidden” UV damage in a roundsling? The answer is yes! On February 16, 2010 the United States issued a patent to Slingmax® Rigging Solutions (US #7,661,737) for a pre-failure warning indication system for all roundslings. It’s called the Check-Fast® inspection system. The following is a brief explanation of how it works.

sling made with the Check-Fast® inspection system adds an extra wrap called a “sacrificial strand.” The ends of this independent strand are equally tensioned among the other load bearing core yarns via a “weak link.” The weak link material has a calculated lower breaking strength than the core yarn material. Also, it degrades faster when exposed to ultraviolet light. Therefore, when the sling is exposed to severe overload or in this case, severe UV damage, the weak link breaks first, well before the remaining strands reach their failure point. Finally, a colored External Warning Indicator (EWI) strand is attached to the weak link and will disappear inside the sling cover when the weak link fails. This is what the rigger looks for upon each inspection. If you see this indicator yarn and there is no other cover damage, it is a GO! If the roundsling is subjected to severe overload when tensioned, or in this case, severe UV deterioration, the weak link breaks and whips the indicator strand inside the cover so fast it makes an audible POP sound.

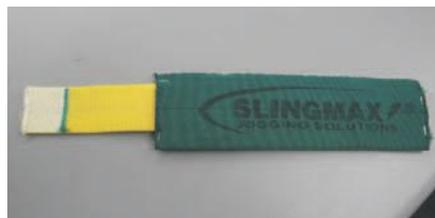
Pictured above is yellow 9800GN nylon web sling material protected by Slingmax® Covermax® roundsling tubing. The exposed webbing faded to white after 334 hours of UV exposure. When the nylon web was pulled out of the protective Slingmax® cover, you can see the original yellow color remains. It shows no UV degradation to the protected webbing.
