# Smart Slings Monitor Lifts, Can Alert Crew to Overload

## Smart Sling Case Study: Leesport, Pennsylvania, State Route 1003 Pedestrian Bridge

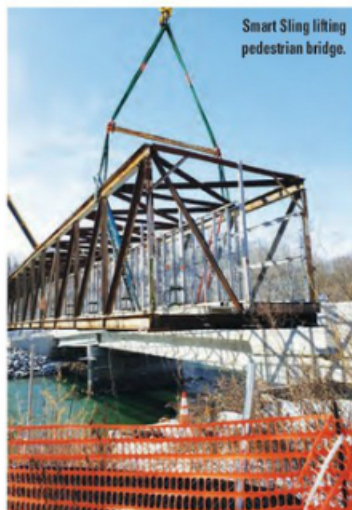
Smart Sling lifting pedestrian bridge.

To have greater insight into the status of the lift, J.D. Eckman incorporated Slingmax Smart Slings into the lift plan.

Battery-powered electronic sensors inside Smart Slings continually monitor for severe overload. During a within-capacity lift, the sensors transmit a "normal" signal to a computer base station every 30 seconds. That lets a designated person continuously watch the safety of the lift while coworkers concentrate on other tasks.

In the case of a severe overload, Smart Slings instantly transmit an "overload" signal to the base station, which then displays an alert on its screen and sends text messages and emails to everyone who's registered in the system.

The Leesport bridge lift crew was trained how to properly rig and use Smart Slings. Since crew members were already familiar with Twin-Path synthetic round slings, the only added thing they needed to remember was not to rig on the orange "no-rig zone."

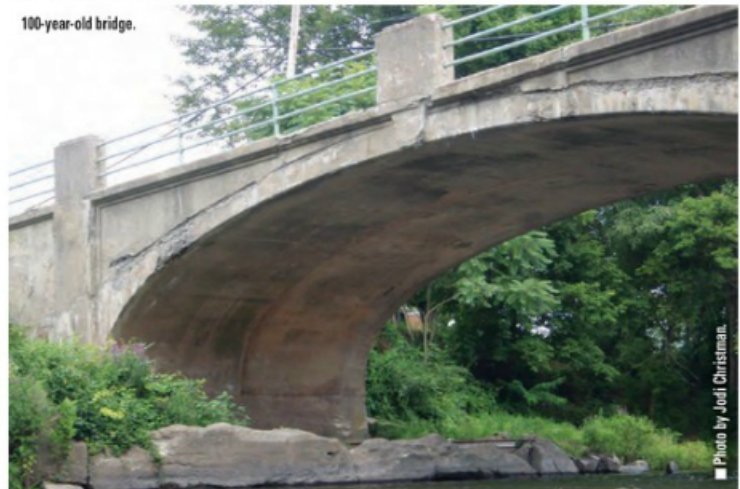
100-year-old bridge.

In one recent project, Eckman replaced a 100-year-old concrete arch bridge spanning the Schuylkill River in Leesport, Pennsylvania. The bridge carried State Route 1003 along with a pedestrian sidewalk, making it an important link between the two parts of town divided by the river.

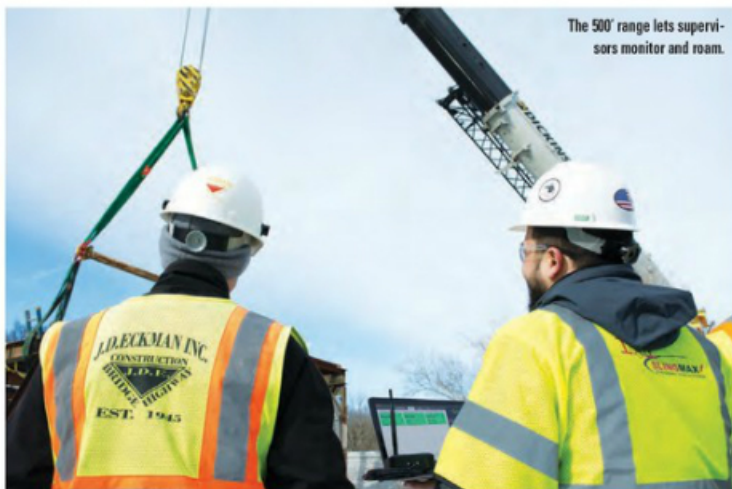
The 500' range lets supervisors monitor and roam.

The base station's 500' transmitting range let supervisors monitor the lift on a battery-operated computer as they walked around the site to observe the crews and all phases of the procedure.
