Technical Bulletin 9A: Cyclic-Tension fatigue of Twin-Path® Slings

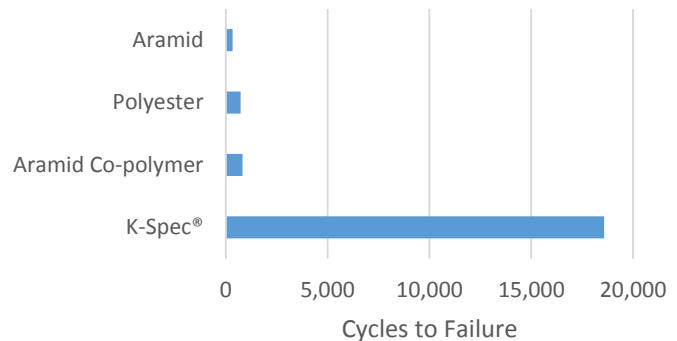
Figure 1- Yarn on Yarn Abrasion Results

The other factor is the degree of internal abrasion due to construction, friction and material type. In this case, as the strength members of the sling rub against each other they wear due to abrasion. These effects can be mitigated by choosing a sling material that has a low coefficient of friction and is resistant to abrasion as well as selecting a construction that minimizes cross-over between strength members. When there is cross-over, such as in a braided construction, each point acts in a sawing action leading to internal abrasion damage. As shown in Figure 1 K-Spec® has superior abrasion characteristics compared to other sling fibers.

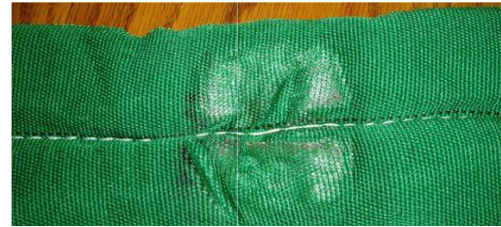
Figure 3- Loading Point After 50,000 Cycles

Testing was performed on a MTS 225 ton horizontal tensile test machine. During the cycling, temperature was measured by inserting a thermometer into the center crease of the sling as close to the loading surface as possible. After 50,000 cycles, the slings were inspected for damage, each showed some hardening and wear at the contact point as shown in Figure 3, but all remained intact.

Results of the cycle test are listed in Tables 1 – 3 below. In each case, the Twin-Path® Slings with K-Spec® remained intact for the full 50,000 cycle test, and in cases of tests 1 and 2, the steel fixture actually had to be replaced due to failure during cycling. In the case of the sling that was pulled to failure, it still had 84% of its original minimum breaking strength, giving it a design factor of 4.2:1 after cycling to a 50% overload 50,000 times.
